Landing Approach to Taxiway at San Francisco International Airport (SFO)

Accident No: DCA17IA148
Accident Type: Office of Aviation Safety
Location: San Francisco , CA
Date: 7/7/2017

Update August 2, 2017:

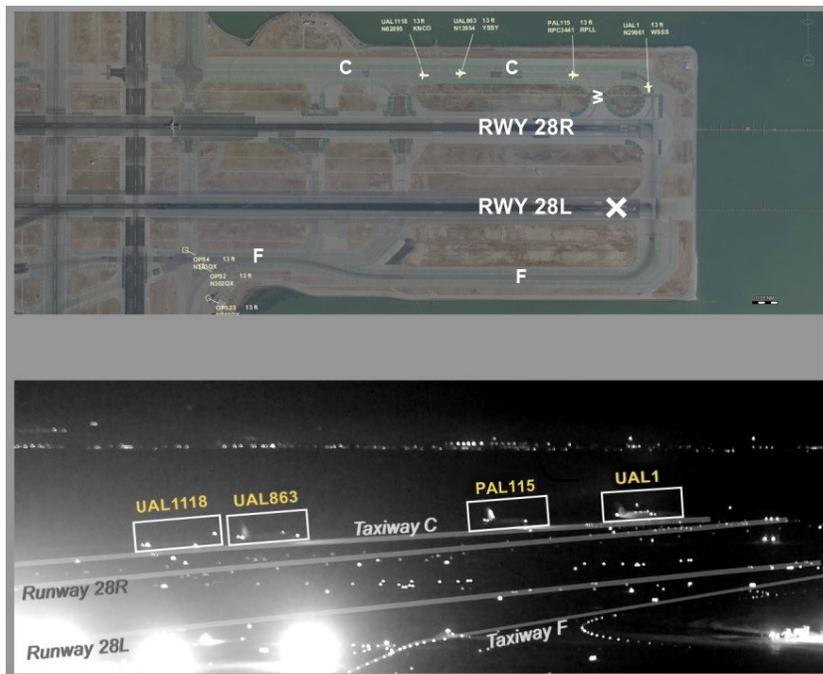
Figure 1 shows the positions of the airplanes on taxiway C. The top diagram is from Harris Symphony OpsVue radar track data analysis, and the bottom picture is from the SFO airport video. Altitudes are shown in mean sea level (msl); ground level is 13 ft msl. Airplanes in the top diagram are not to scale.

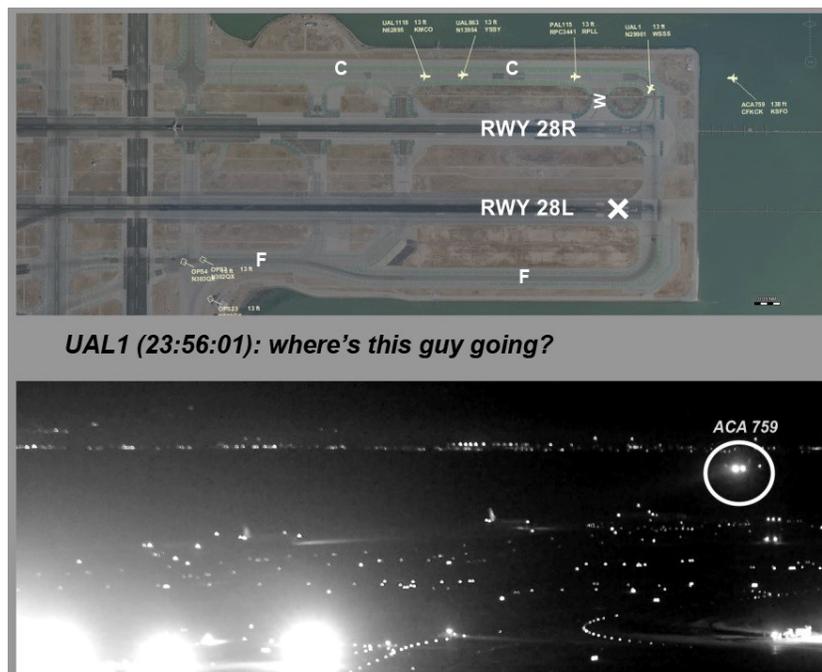
- The flight crew of the first airplane in queue on taxiway C (UAL1) transmitted statements regarding ACA759, one of which mentioned the alignment of ACA759 with the taxiway while ACA759 was on short final (see figures 2 and 3). The flight crew of the second airplane in queue on taxiway C switched on their airplane's landing lights as the incident airplane approached.

Figure 2 shows UAL1's transmission at 2356:01 and ACA759's position as it approaches the taxiway.

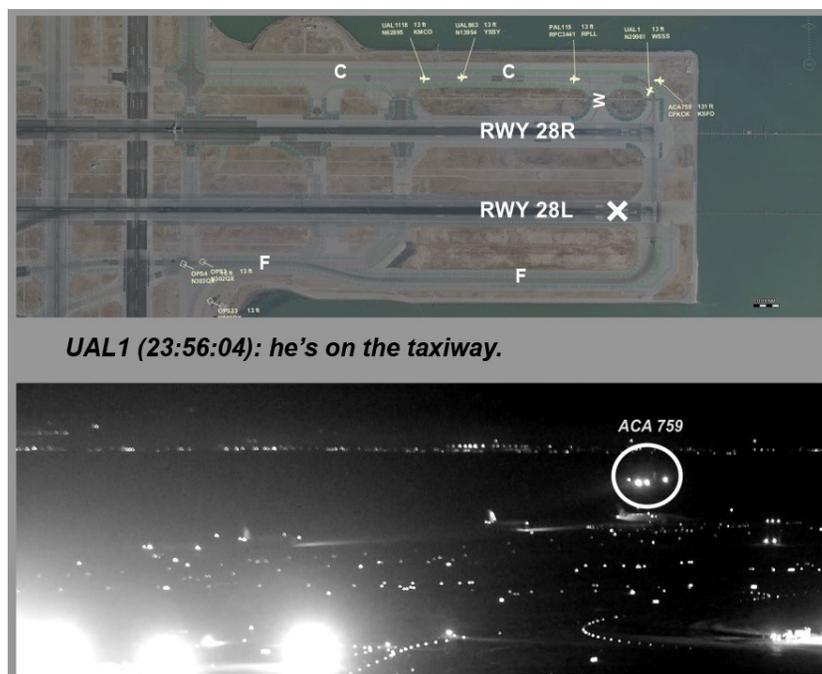
Figure 3 shows UAL1's transmission at 2356:04 and ACA759's position as it overflies the first airplane waiting on the taxiway; note that the second airplane has turned on its landing lights.

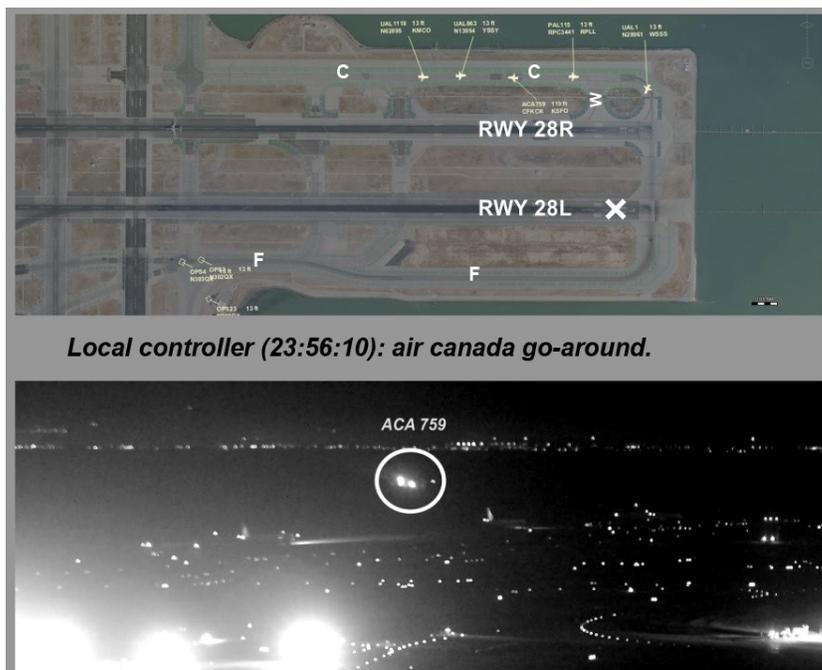
- The incident pilots advanced the thrust levers when the airplane was about 85 ft agl. FDR data indicate that the airplane was over the taxiway at this time, approaching the vicinity of taxiway W.
- At 2356:04 PDT, ACA759 reappeared on the local controller's ASDE-X/ASSC display as it passed over the first airplane positioned on taxiway C.
- About 2.5 seconds after advancing the thrust levers, the minimum altitude recorded on the FDR was 59 ft agl.
- At 2356:10 PDT, the local controller directed ACA759 to go around. The airplane had already begun to climb at this point (see figure 4).

Local controller (23:56:10): air canada go-around.

Figure 4 shows the local controller's transmission to ACA759 at 2356:10 to go around and ACA759's position after overflying two airplanes on the taxiway.
